# Reducing Soil & Water Losses from Arable Fields

## Project Background

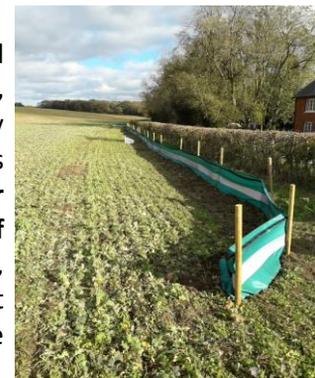
A **catch pit** is a 2m long pit dug into the ground, lined with plastic. The catch pit has a plastic roofed covering to prevent any rain water getting in. This makes sure that the catch pit just collects the water and sediment from surface or overland flow from that particular field.

This trial is a **novel and innovative design**, which worked very successfully as it allows us to **quantify both water and sediment run off overland** via the catch pit, and the sediment movement at the sediment barrier itself.

A **sediment barrier** is a concept borrowed from the construction industry where it acts as a **physical barrier to stop sediment run off**.

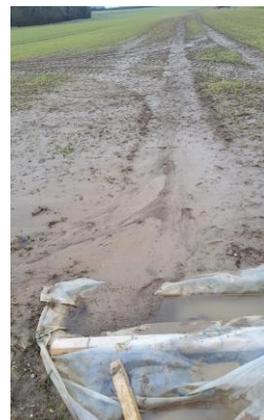
The individual pesticide limit for drinking water is 0.1µg/l (ppb), the following results were obtained across the three sites. The highest results were all from Site 1 - This field was drilled following the slope and had increased cultivations compared to the other sites.

Herbicide	Min µg/l	Max µg/l	Avg µg/l
Flufenacet	0.127	10.14	2.2
Prosulfocarb	0.025	0.992	0.3
Glyphosate	0.14	4.97	1.4
